## MM-Info „Industry“

Info folder with branch specific information of chosen PolymerMetals  
for customers from the industry sector

# PolymerMetall®

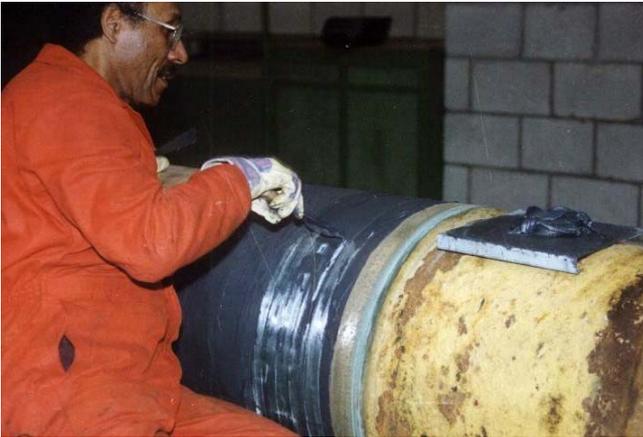
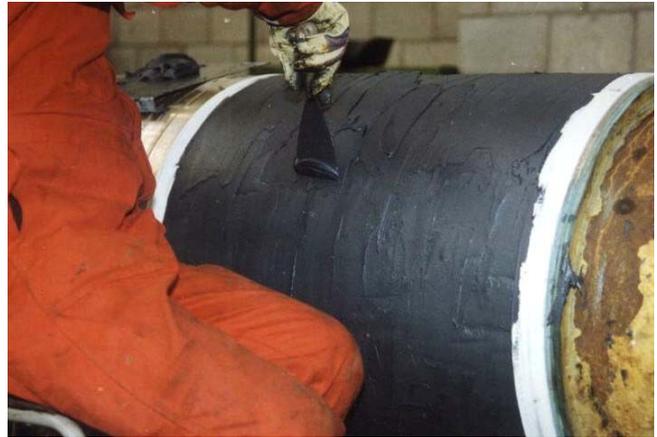
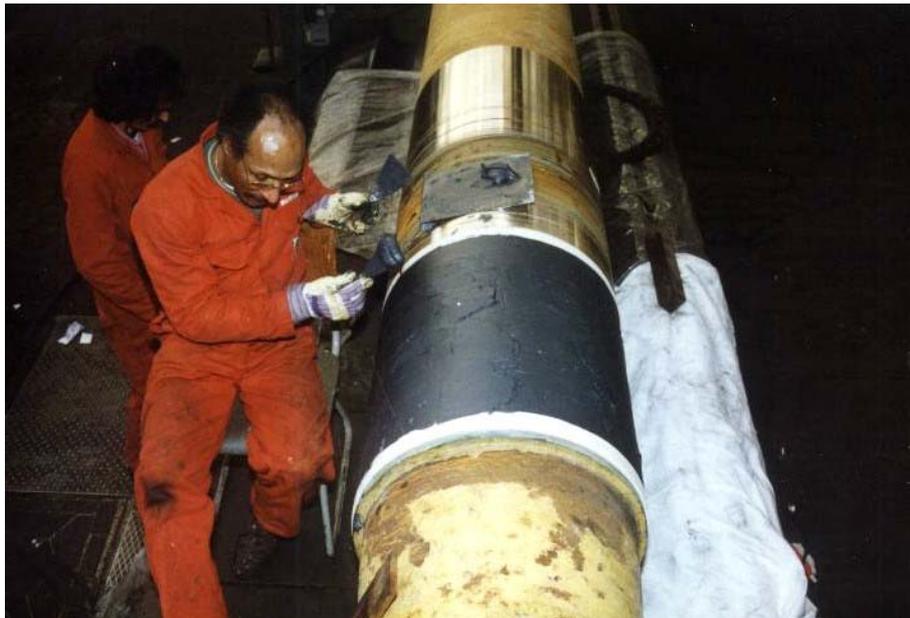
REP-# 093

Repair of a ship propeller shaft made of bronze in the zone of the stuffing box packing with Ceramium pasty and Hardener CE. The original shaft diameter of 630 mm was machined down to 615 mm over a length of 60 cm. After the application of Ceramium the diameter was 632 mm. Finally the applied Ceramium was turned down to the requested diameter. For the complete repair 39 units of Ceramium / Hardener CE were used for applying 4 layers. Additionally 3 layers of glass fibre fabric tape were processed.

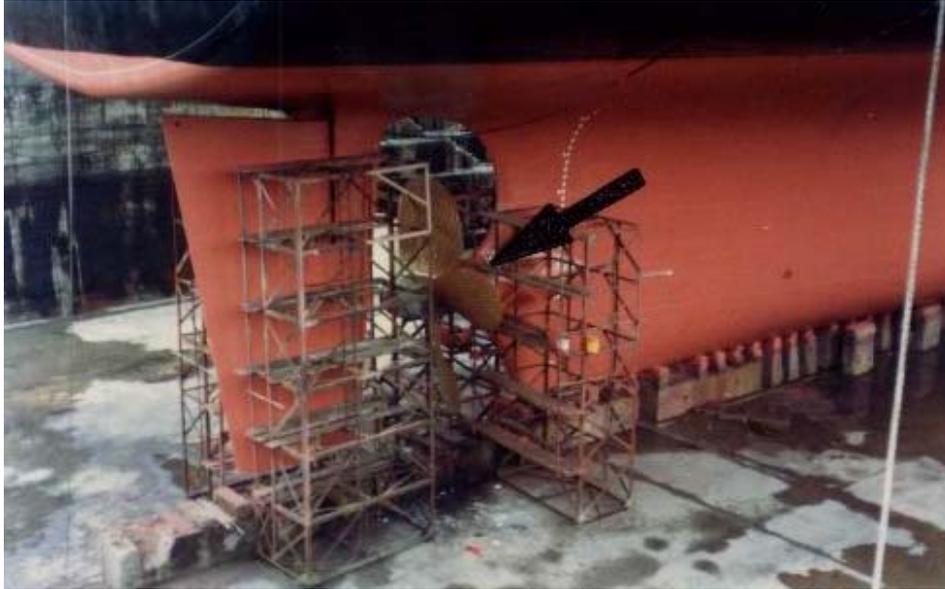
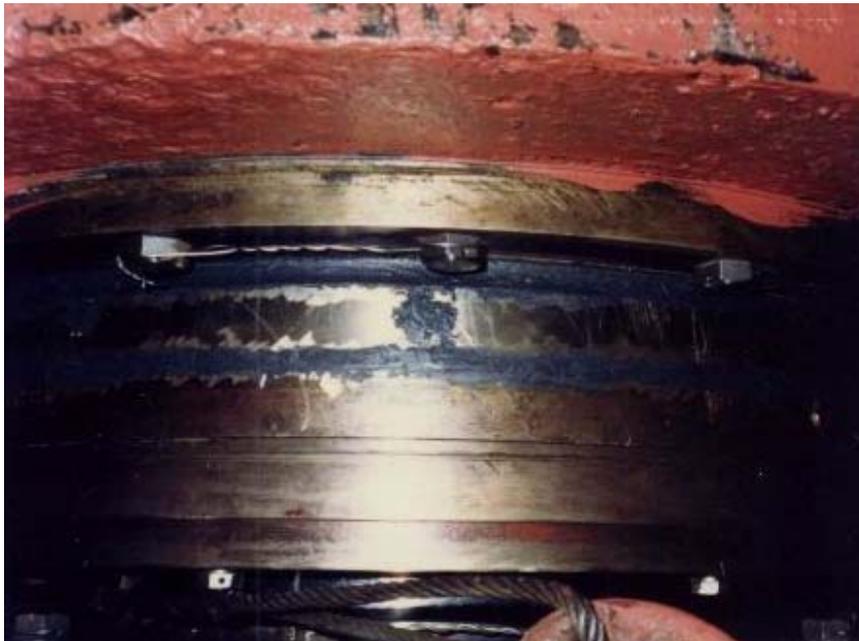
**REP-# 115**

Repair of a leaking simplex compact packing. The repair was difficult due to oil pouring out of the repair site. Therefore it was decided to use the direct-MM-bonding method by applying the PolymerMetall directly on the greasy surface. Here MM-metal oL-steelceramic with Hardener red was chosen.

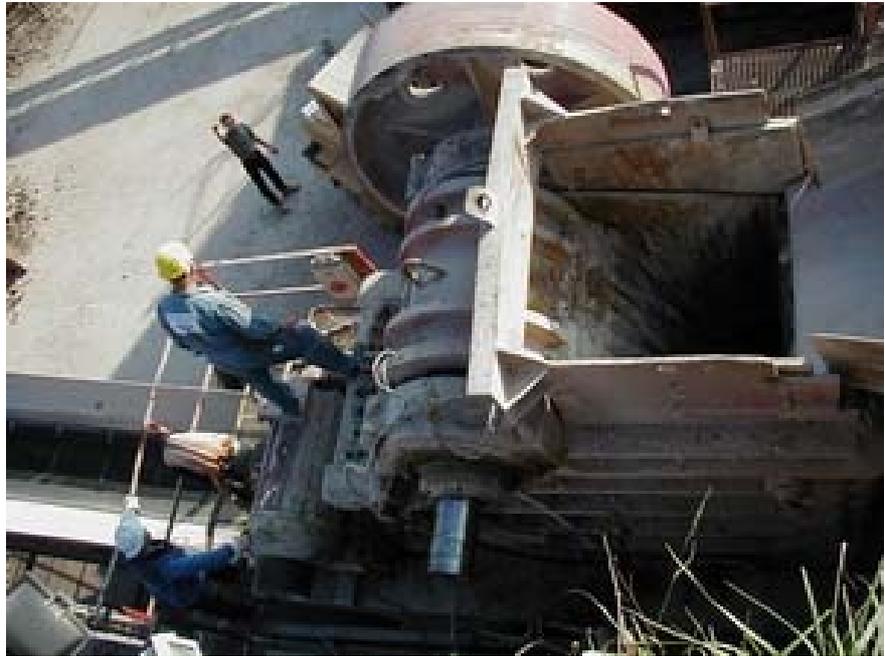
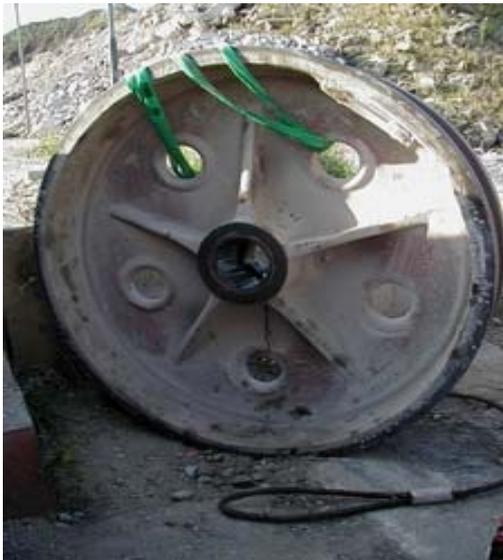
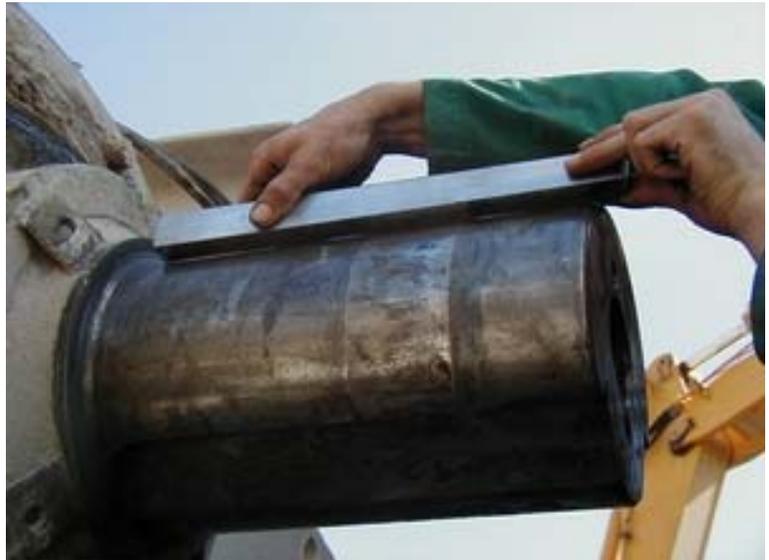
REP-#139

After many years of working, the worn-out rock shaft of a crushing plant for recycling demolition material was repaired with MM-metal SS-steel 382 in September 2002. First the driving fly wheel was carefully dismantled to receive access to the shaft. After the surface preparation of the up to 1 mm worn-out shaft area, MM-metal SS-steel 382 was applied and then machined down to the desired diameter. A replacement due to the necessary dismantling of the damaged shaft, the purchase and the assembly of a new shaft, would have involved considerable additional costs and time. An examination 4,5 years later (March 2007) has come to the result, that the repaired work piece is still in function without any complaints.

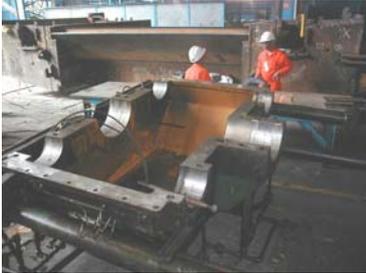
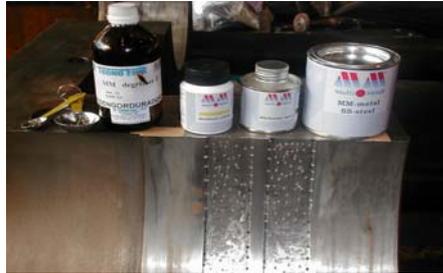
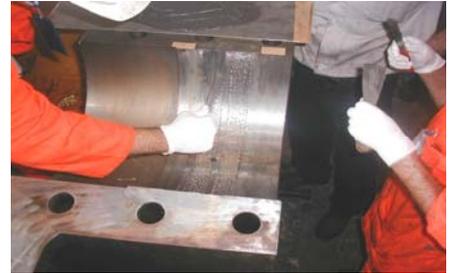
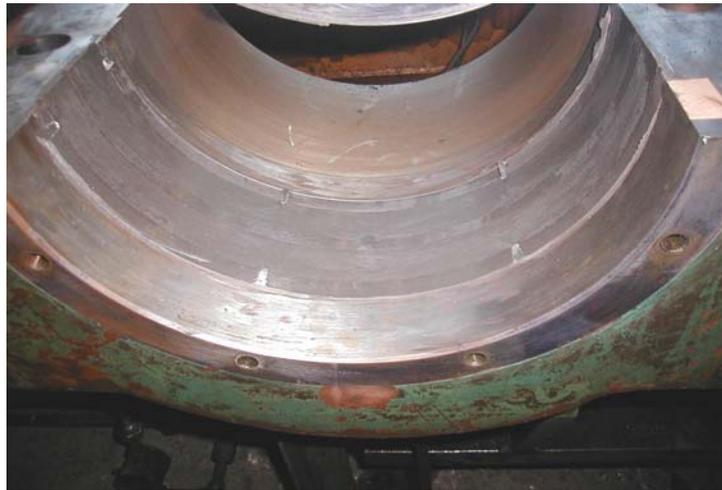
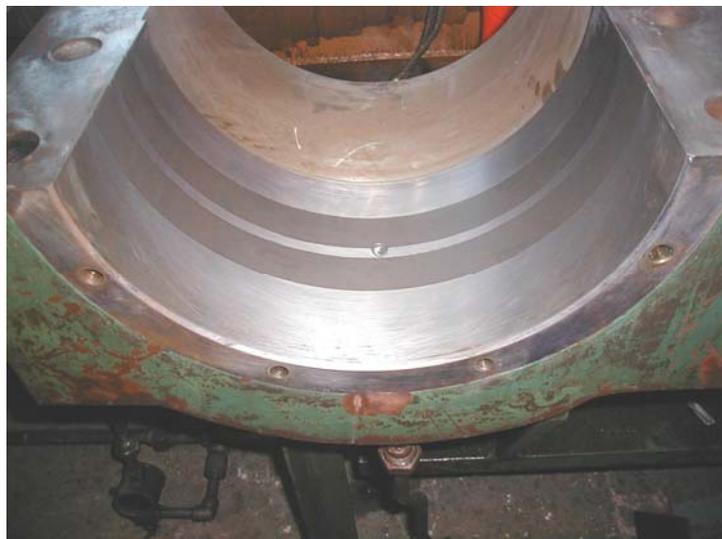
REP-#140

In a steel plant the repair of a broken spool reducer with a weight of 40 t would have taken up 10 days by using the conventional way of welding. By using the repair technology of MultiMetall combined with the PolymerMetal MM-metal SS-steel and MM-Release agent a repair time of just 27 hours was necessary. At the spool reducer a stress of 120 MPa occurs.

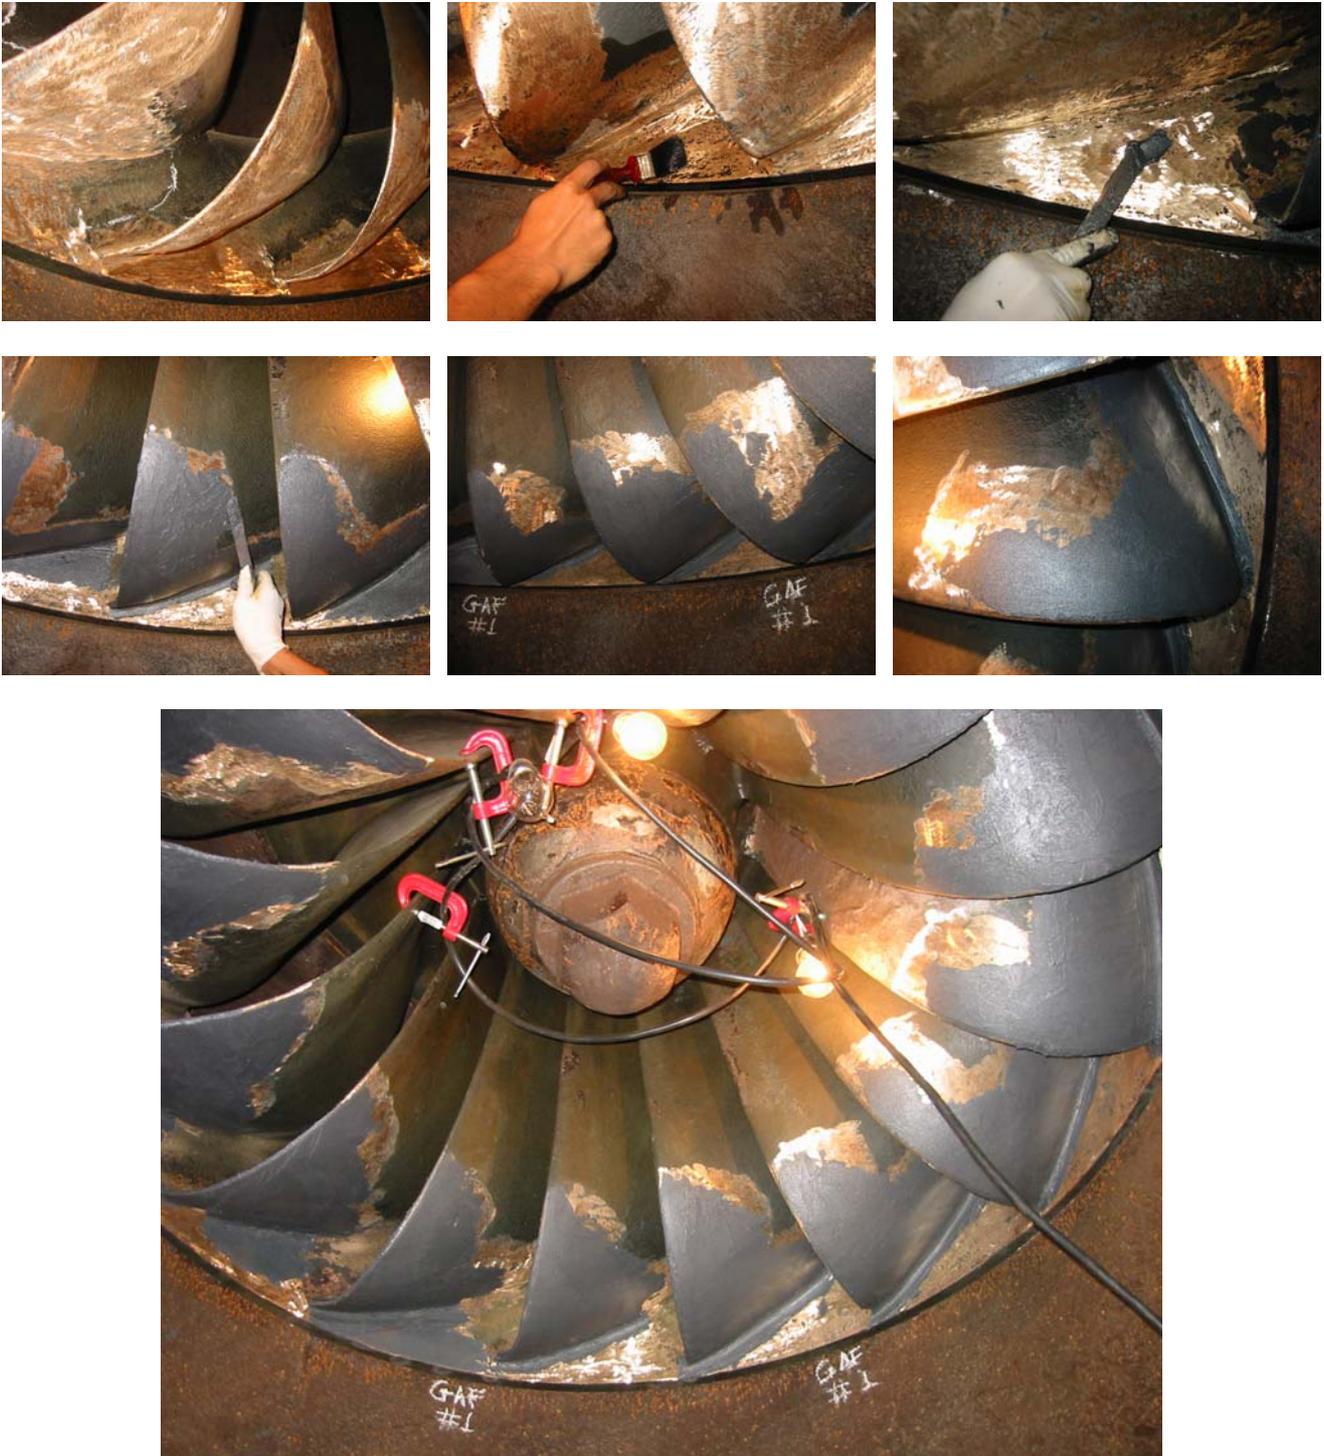
REP-#144

A turbine paddle was worn out caused by a water-sand-mixture. The pasty variant of the PolymerMetal Ceramium was used to rebuild the worn-out areas.

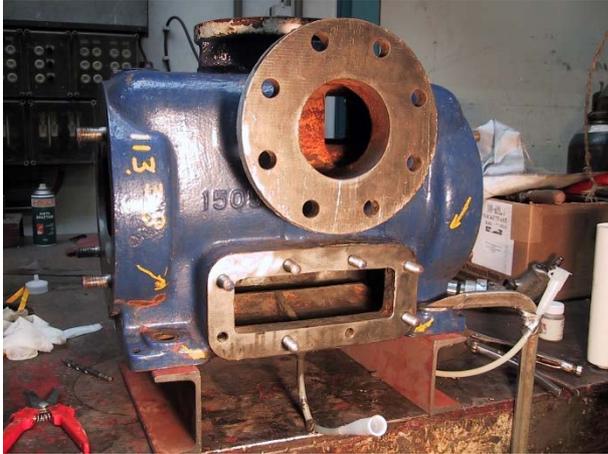
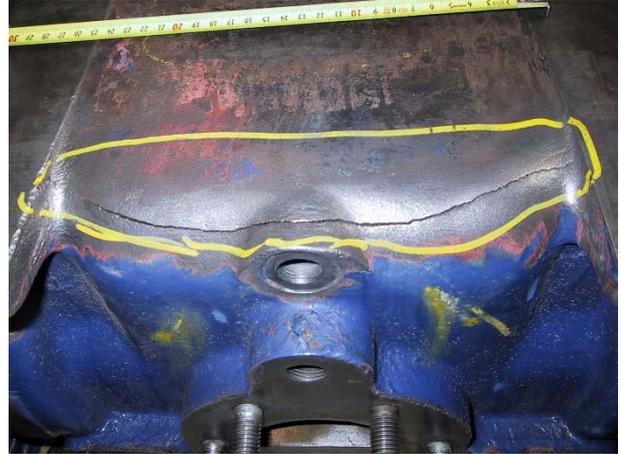
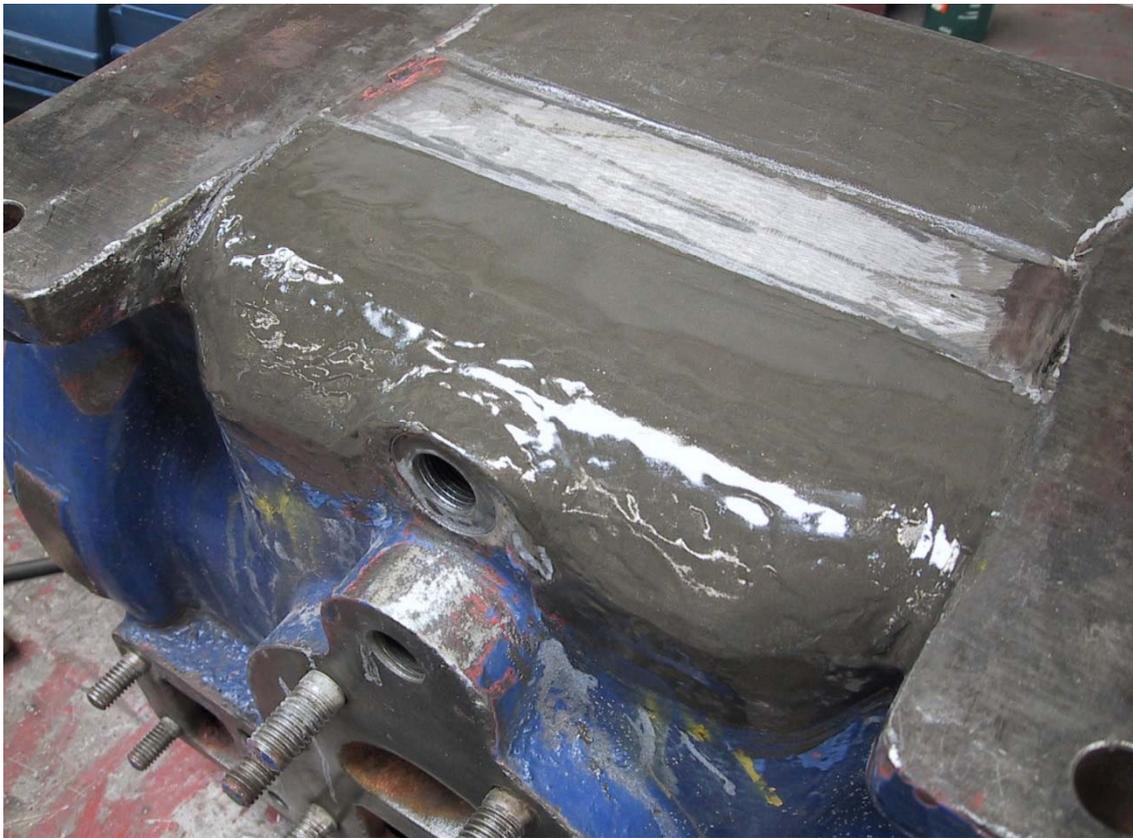
REP-#150

A broken pump casing was repaired with the help of the PolymerMetal MM-metal SS-steelceramic.

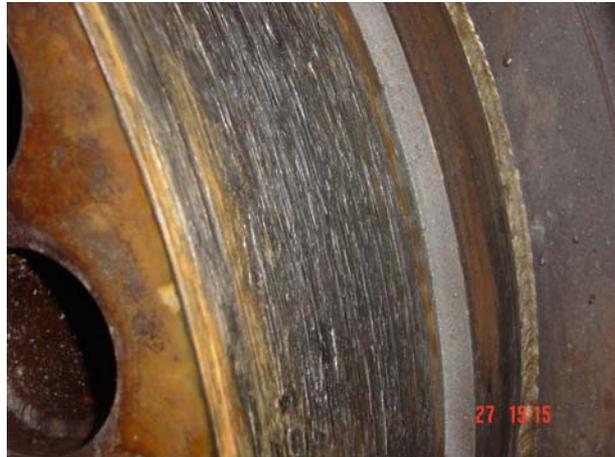
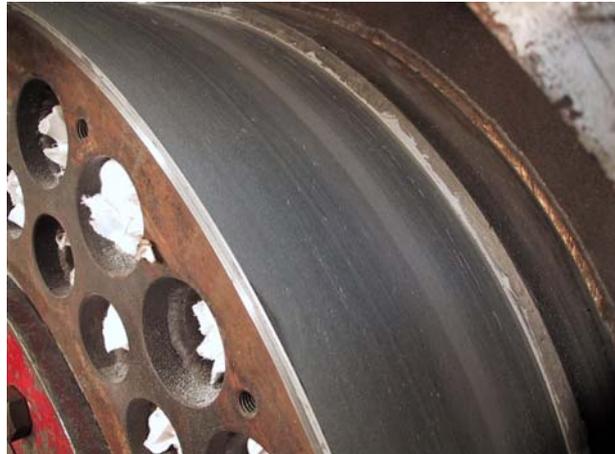
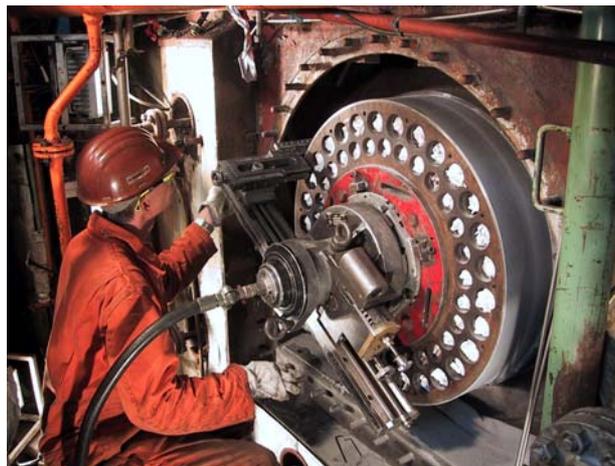
REP-#152

Onto a damaged area of an axle end MM-metal SS-steel, later MM-metal SS-steel 382 was applied to receive a higher surface quality. After curing, the work piece was machined down with a lathe to the desired diameter.

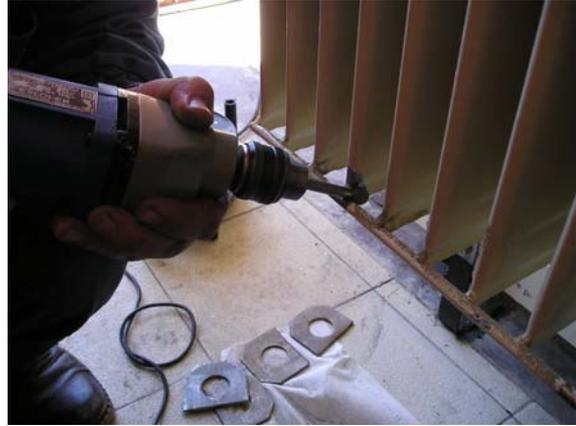
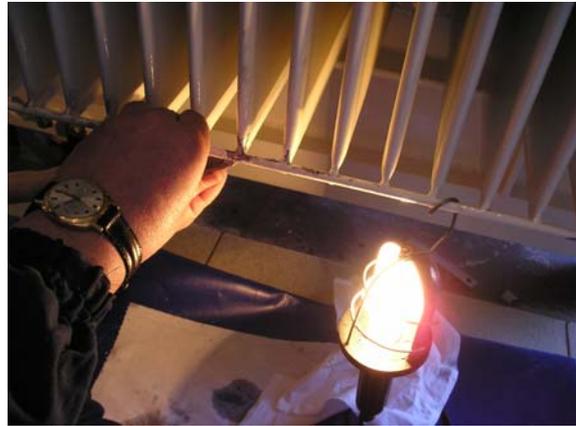
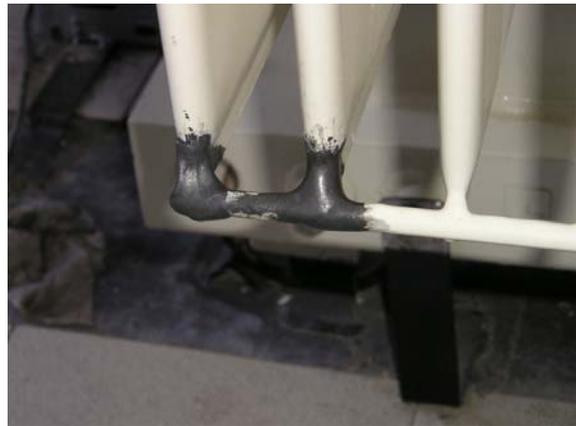
REP-#156

The welding at 19 places of transformers had micro cracks and blowholes, where oil exuded. First the paint has been removed with an electro drill equipped with an abrasive tool and the metal has been cleaned at the defective areas. Then MM-metal oL-steelceramic with Hardener red and afterwards Hardener yellow was applied. After checking the tightness of the repaired areas the corresponding areas have been painted over again.

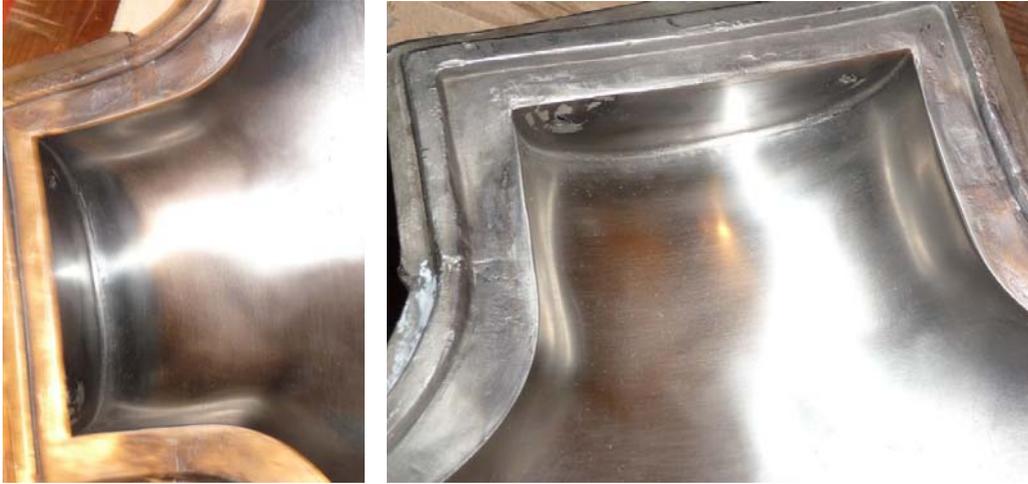
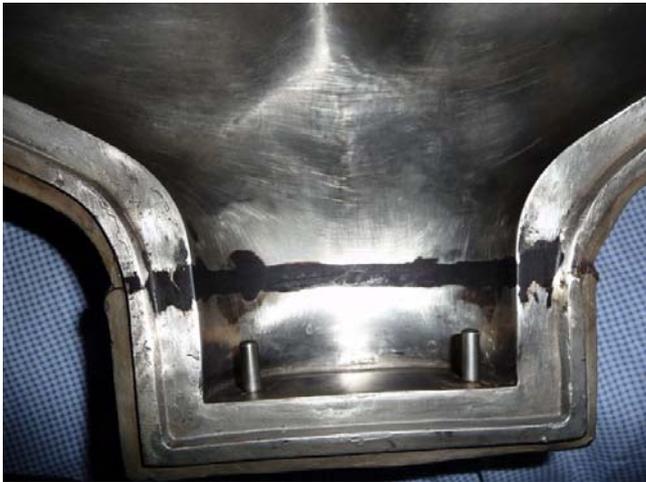
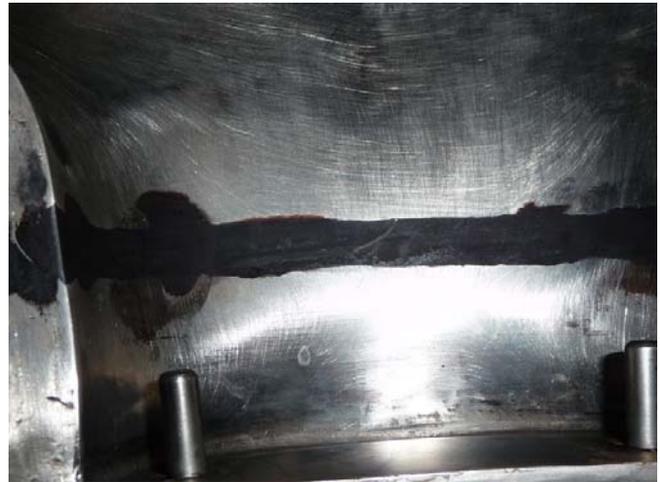
REP-# 163

A tool form of nickel for the torsos production of complex medical rubber dummies had to be adapted in the cervical region. The form was first cut in the cervical area. The attempt by soldering to join again the parts of the form being adjusted in the meantime, failed. Leakages by embedded air bubbles occurred in the cast parts in the area of the seam. By the alternative application of Ceramium BD the form could be put into operation again successfully. The seam was grinded 2 mm deep, cleaned with acetone and warmed up in the stove on 100 °C. Then Ceramium BD was applied in the repair area. After sufficient curing of approx. 1 - 1,5 hours the form was grinded and covered with Sealium respectively immersed in Sealium. The result was a clean surface without noticeable passages in the seam. The form stood firm easily the working temperature of 265 °C.

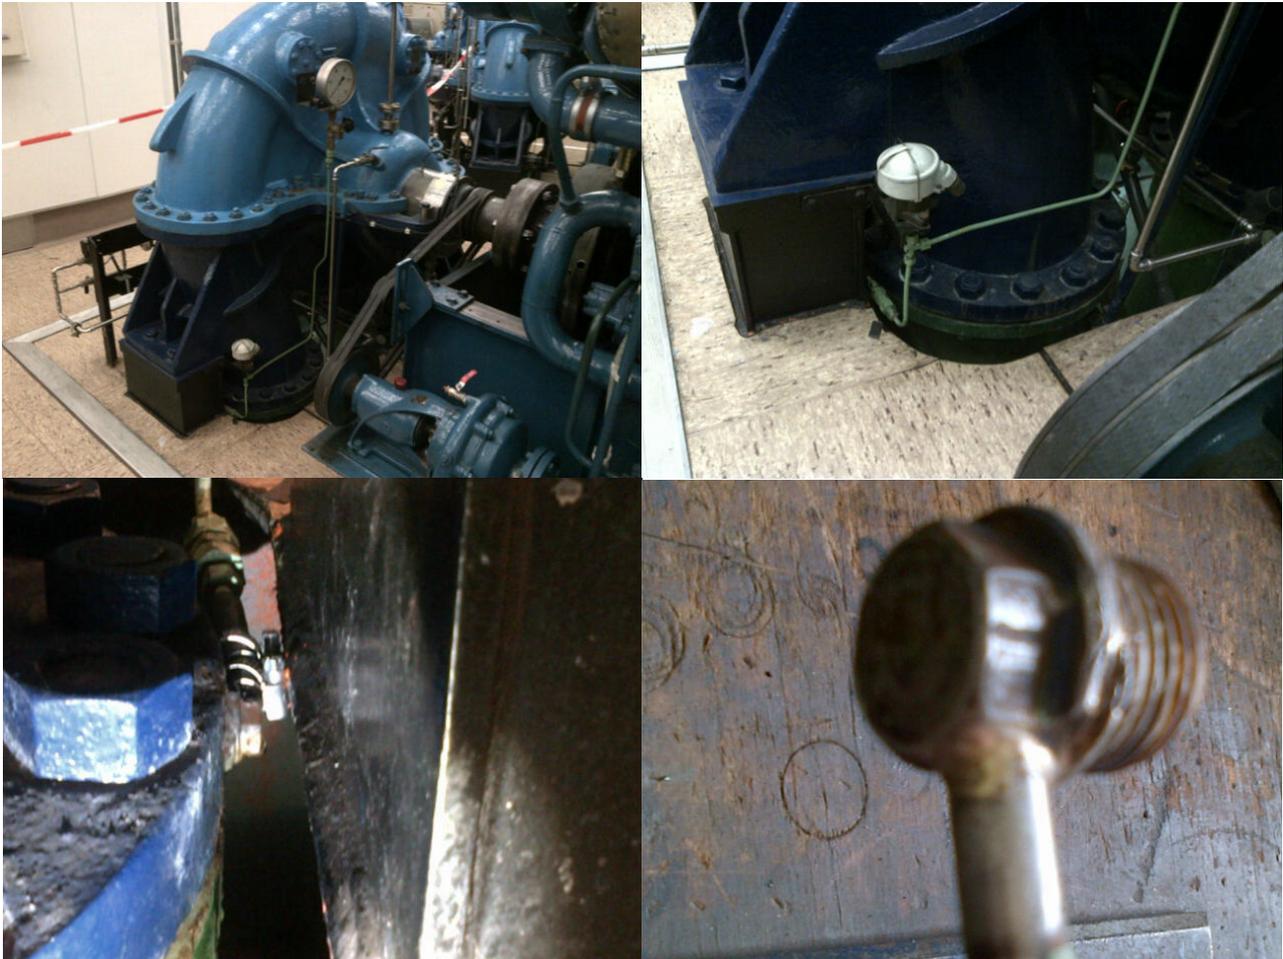
**REP-# 170**

The pump capacity of a diesel pump decreased due to a leakage. There was a small leak probably resulting from an untight soldered seam or a crack in the copper pipe at a difficult accessible repair place at a measuring plug. A soldering/welding linked the measuring steel plug (diameter approx. 25 mm) with a 3/4-inch copper pipe. By using MM-metal SS-steelceramic and Hardener yellow the damage was repaired and later the customer (a water treatment company) put the pump into operation again with the usual working pressure of 16 bar.
