## MM-Info „Ship“

Info folder with branch specific information of chosen PolymerMetals  
for customers from the shipping sector

# PolymerMetall®

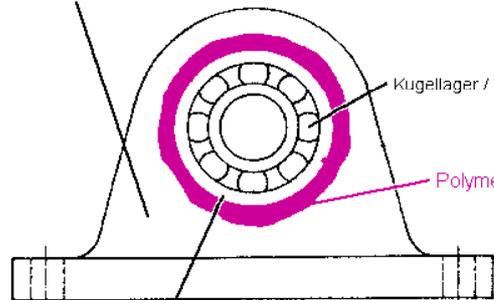
Lagerblock / pillow block

Kugellager / Ball bearing

PolymerMetal

MM-Trennmittel / MM-Release agent

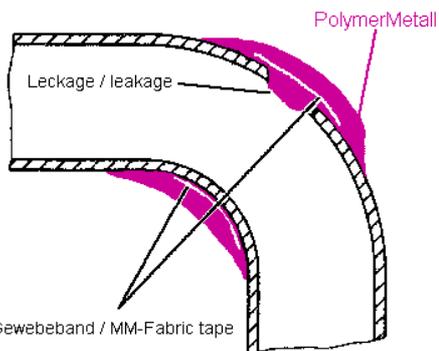
Leckage mit Flüssigkeitsaustritt /  
leakage with liquid pouring out

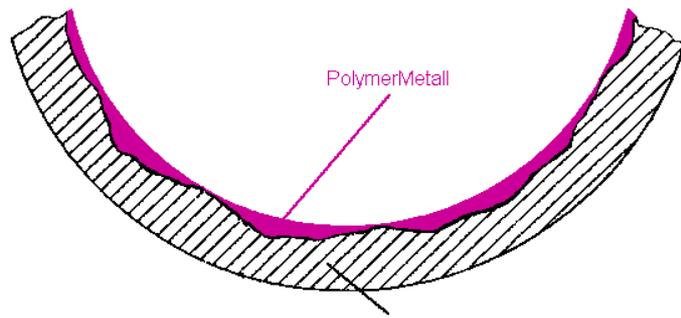
MM-Gewebeband / MM-Fabric tape

verschlissenes Pumpengehäuse / worn pump casing

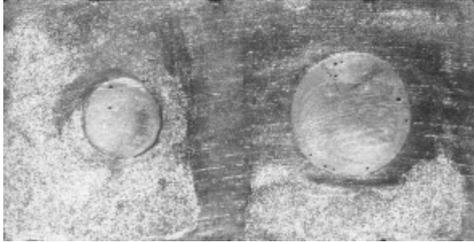
The following photographs show the different PolymerMetals applied to cast iron which have been partly machined after full curing. After they have been stored for 12 months in aggressive moorland or artificial sea water the samples have been examined. The following four photographs concern machined samples which have been exposed to artificial sea water:

Sample MM-metal SS-steelceramic

The results of both tests were nearly the same. Due to the strong reaction caused by the aggressive soil or by the sea water the cast iron plates were coated with ferric hydroxide. While the surface of the cast iron plates were differently affected, the PolymerMetals still remained unchanged after storage of more than 12 months. They were only covered with rust deposit. Even peak-to-valley heights from previous treatments could clearly be recognised. There was no contact corrosion, not even at the transitional point of the PolymerMetal and the cast iron. It was proved that PolymerMetals are not electrically conductive and cannot constitute any local element with cast iron.

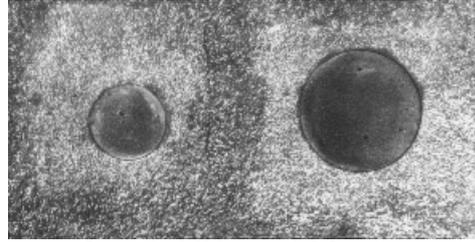
Sample MM-metal SS-steel

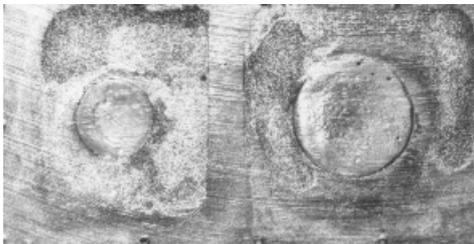
Sample MM-metal oL-steelceramic

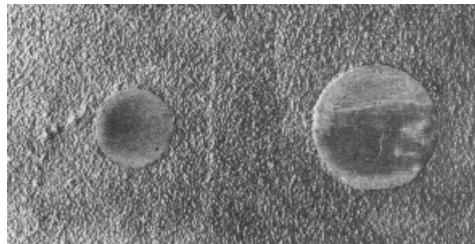
Sample MM-metal UW

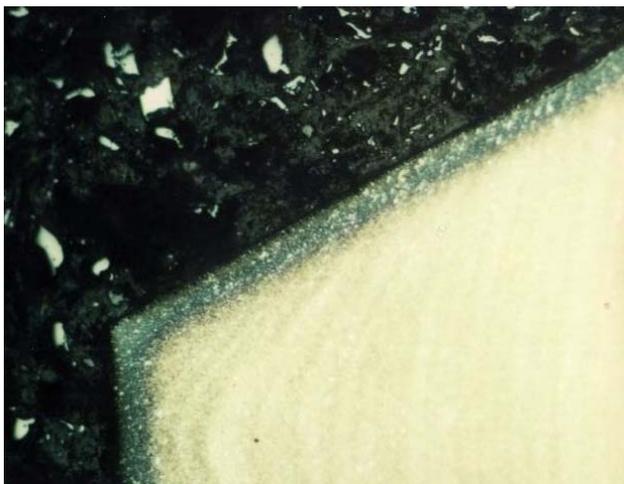
The following pictures show microscopic photographs of the fully cured PolymerMetal MM-metal oL-steelceramic magnified by a factor of 100 and 500. Here the bonding between MM-metal oL-steelceramic and metallic surfaces (steel or casting), which have been contaminated by various applied oils before, has been analyzed.

on industry gear oil / steel  
(Magnification 100)

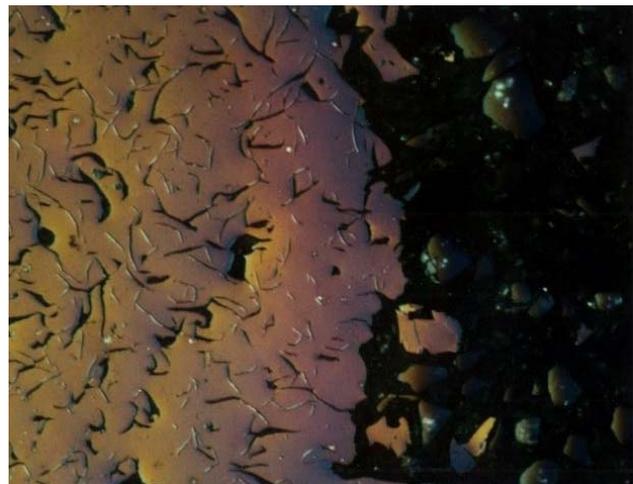
on petroleum / casting  
(Magnification 100)

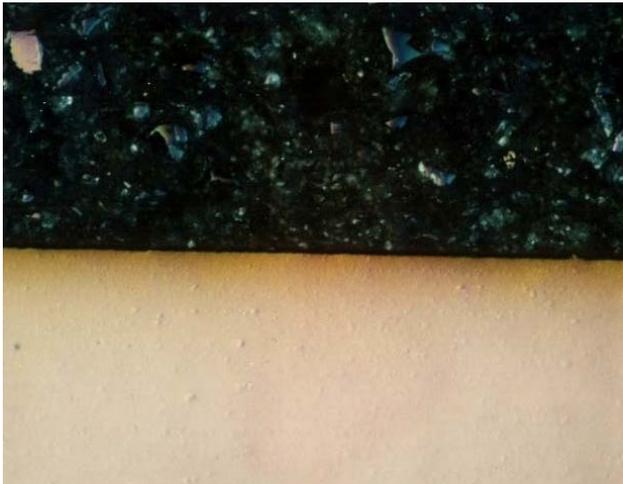
on diesel / steel  
(Magnification 100)

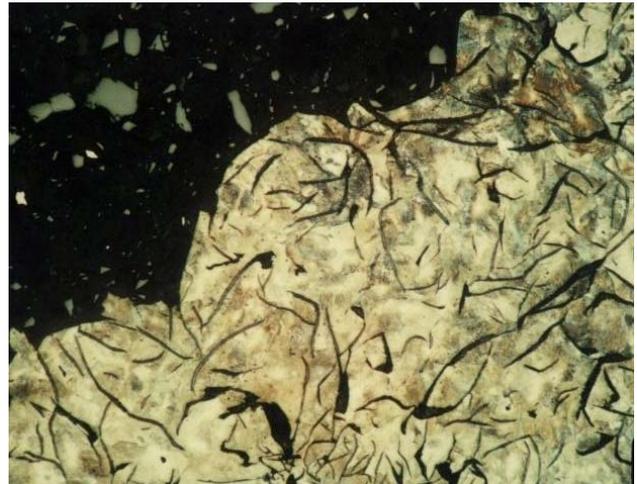
on compression oil KSL 68 / casting  
(Magnification 100)

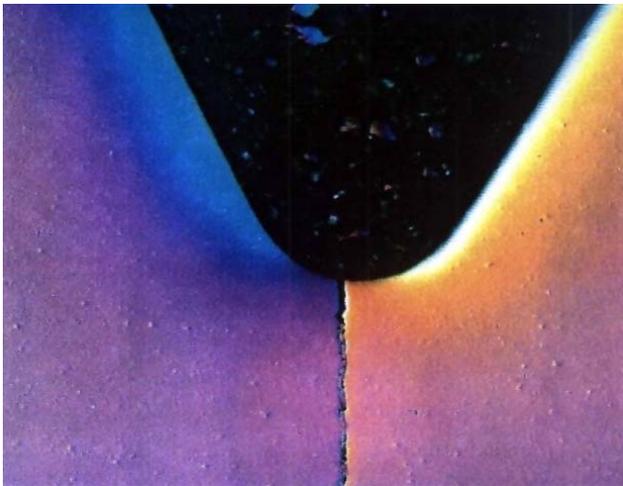
on hydraulic oil T 29-50 / steel  
(Magnification 100)

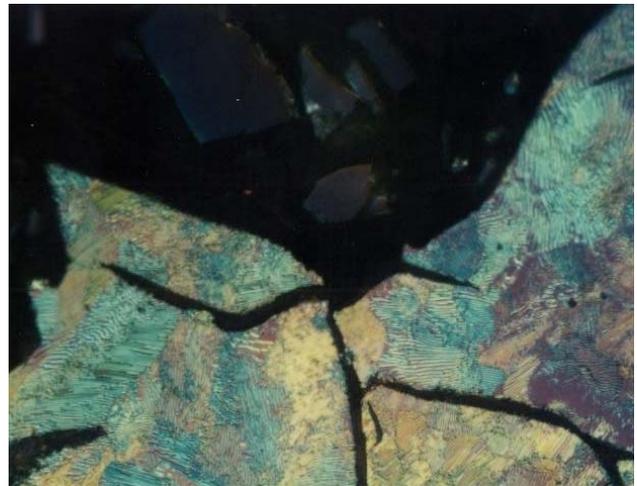
on gear oil / machine oil 55  
(Magnification 500)

MM-metal oL-steelceramic penetrates and absorbs oil, grease and fuel. The direct-MM-bonding technology secures the direct and high solid bonding on contaminated surfaces.

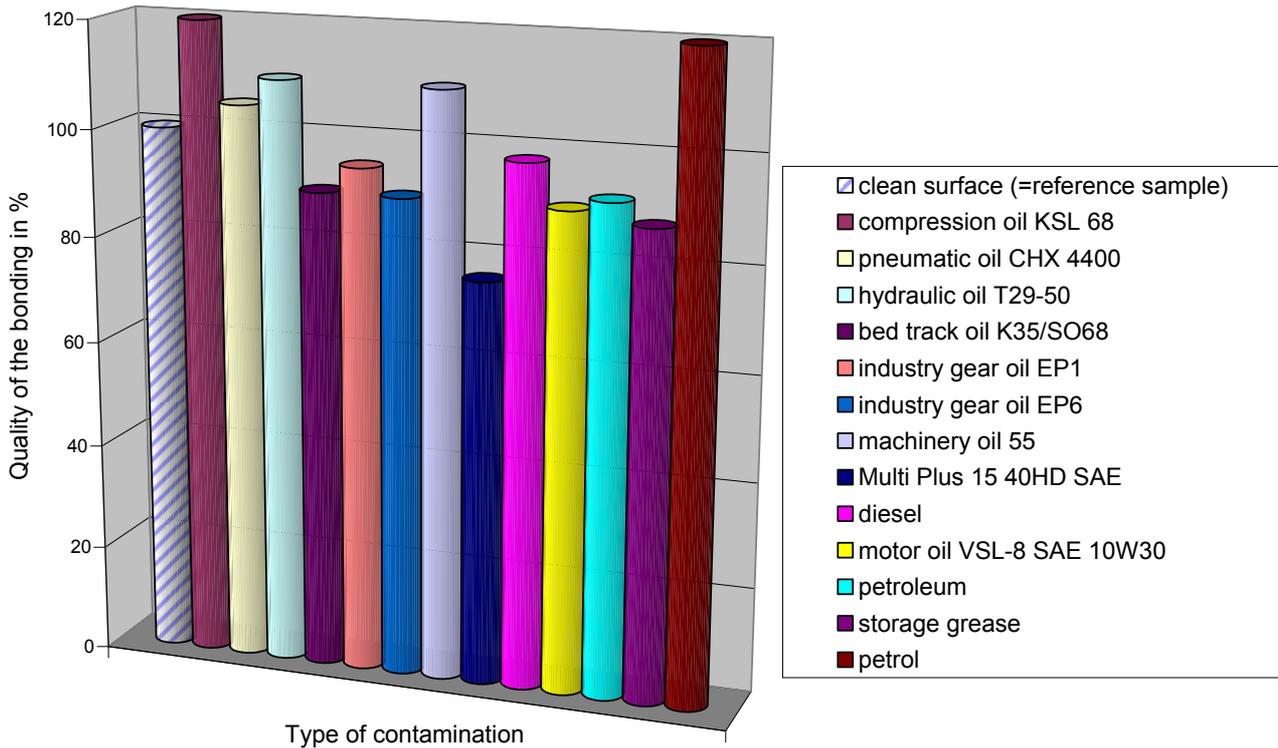
Tests have been carried out to evaluate the quality of the bonding on different surfaces. At the reference test MM-metal oL-steelceramic and Hardener yellow have been applied to a cleaned (that means oil free) and roughened metal surface. The reference value of 100% stands for the quality of the various determined technical data during bending, shearing & hydraulic tests after total curing time. Other values have been determined by applying MM-metal oL-steelceramic on different contaminated metal surfaces. The test results demonstrate that sometimes better technical values were reached after application on oily metal surfaces than on clean metal surfaces.

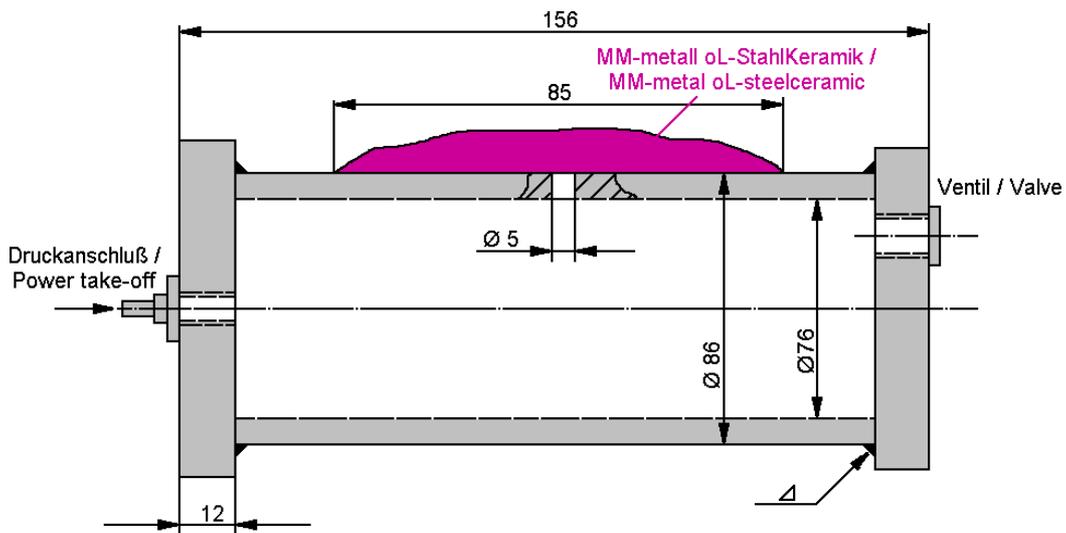
To be able to evaluate the quality of the application of MM-metal oL-steelceramic on oily surfaces, tests have been carried out at company M.A.N. under supervision of the classification society Lloyds Register of Shipping. Here special test pipes made off steel have been created according to the following drawing. Around a leakage of a size of diameter 5 mm the metallic shiny surface (Rz 65  $\mu\text{m}$ ) of the test cylinder was contaminated with oil. Then the cold-curing MM-metal oL-steelceramic with Hardener yellow was applied around the leakage with a layer thickness of up to max. 8 mm. After full curing of the PolymerMetal the test cylinder has been filled with a liquid and pressure was built up. Then the system was checked against pressure tightness.

Pressure	Temperature of test cylinder	Auxiliaries	Result
100 bar	20 °C	-	pressure tight
150 bar	20 °C	-	pressure tight
200 bar	20 °C	-	after 8 hours small leakage

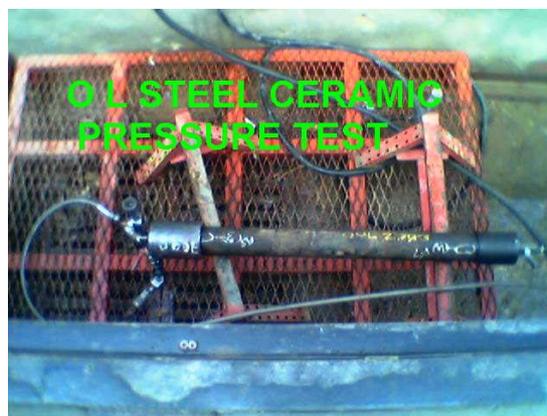
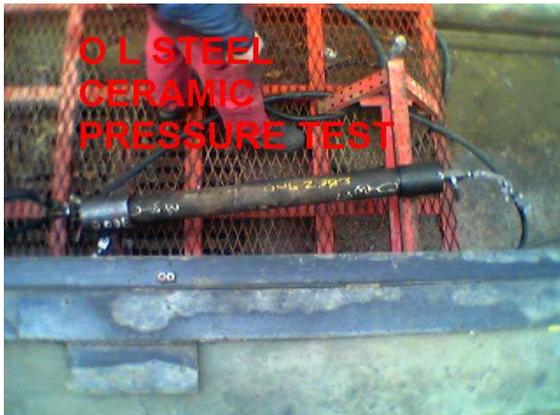
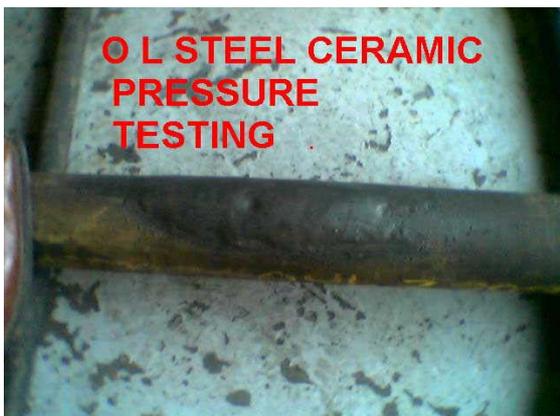
At Weatherford pressure tests have been carried out with MM-metal oL-steelceramic. The test piece was pressure tight up to a tested pressure load of 4.000 psi (~ 275 bar).

Here are some photographs incl. test records:

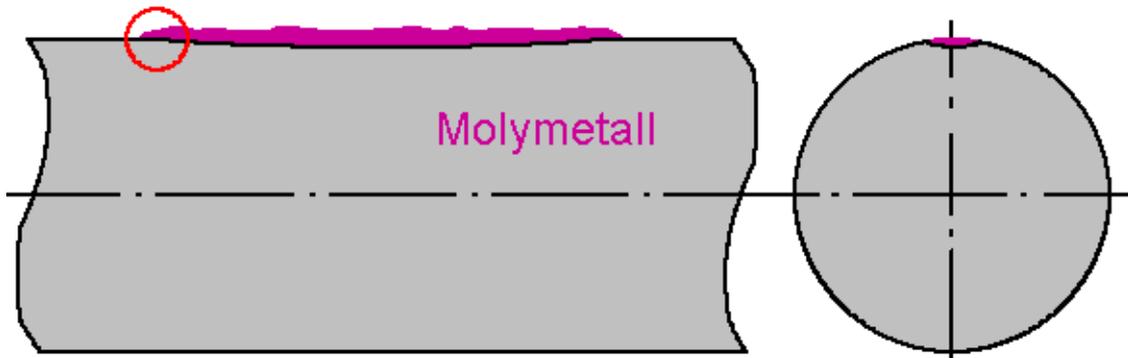
Wrong:

Especially when Molymetall® is used for the repair of hydraulic rams, it is important that the surface of the work piece is thoroughly prepared before coating. Therefore

**make the surface metallically clean and carryable &  
rough up the surface mechanically by sandblasting, cutting, grinding etc.**

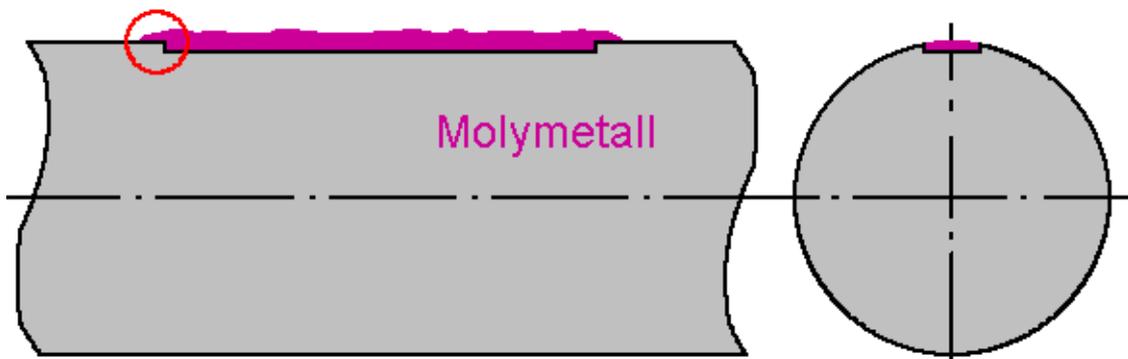
Right:

Especially during the creation of a metallically clean and carryable surface, it is very important that any pittings and cracks on the work piece surface, which were caused by wear won't be let run out, but machined instead. That means that before the application of Molymetall® covering the complete area, any cracks should be grinded down by appr. 1 mm. This way the bonding of Molymetall® on the surface is secured.

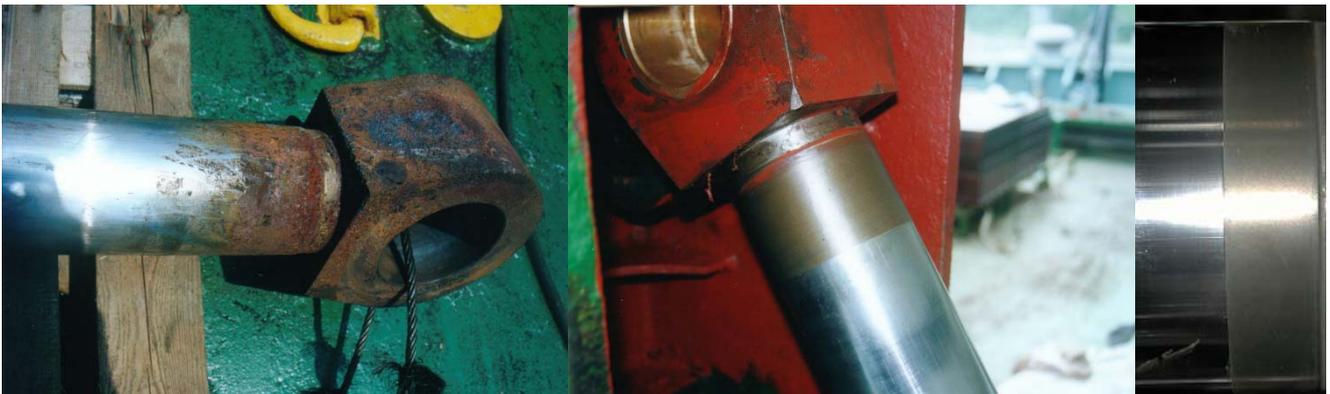
Following some examples of hydraulic rams, which have been repaired with Molymetall®:

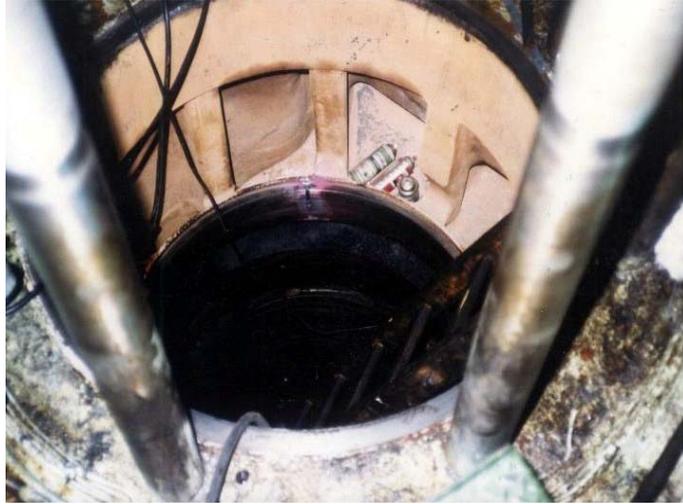
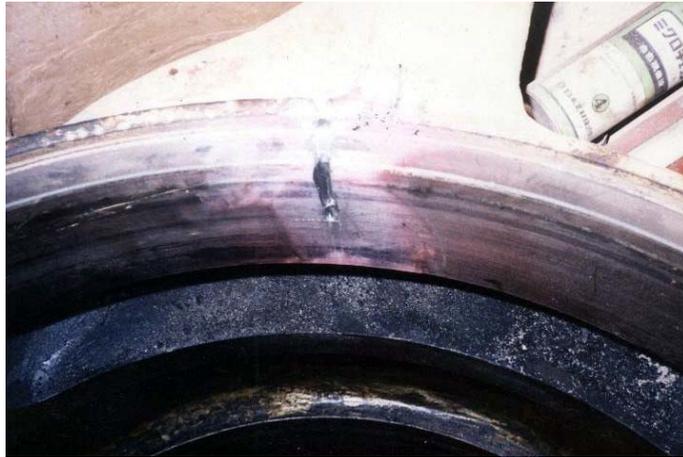
**REP-# 005**

Repair of a marine engine with MM-metal SS-steelceramic and Hardener yellow. Damage: cracked packing surface between cooling water space and cylinder liner.

REP-#	Description
005	Repair of a marine engine with MM-metal SS-steelceramic and Hardener yellow. Damage: cracked packing surface between cooling water space and cylinder liner.
006	Repair of several bilge pumps and fire pumps (type Loew VZLG 65/1/2, power 60 m3/h) with Ceramium pasty and Ceramium liquid. An inspection 3 years after the repair did not show any faults or objections at the repaired object.
010	Sealing of cracked leaky welding seams at crankcase of a ship diesel with MM-metal SS-steelceramic and Hardener yellow.
012	Elimination of damages at two vessel's propeller caused by cavitation with Ceramium and Hardener CE.
016	Repair of cracked Diesel injection pumps using MM-metal SS-steelceramic and Hardener yellow.
019	A worn out bearing bush of a floating dredger was rebuilt using MM-metal SS-steelceramic and Hardener yellow. Besides MM-metal SS-steel liquid type with Hardener yellow liquid was injected into a gap of 4 mm between bearing bush and boom.

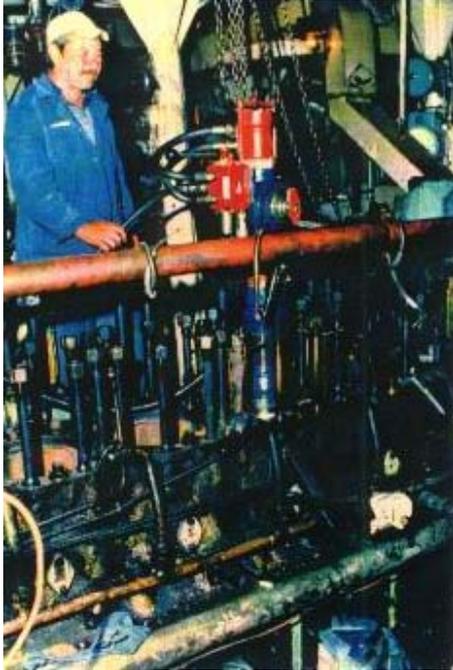
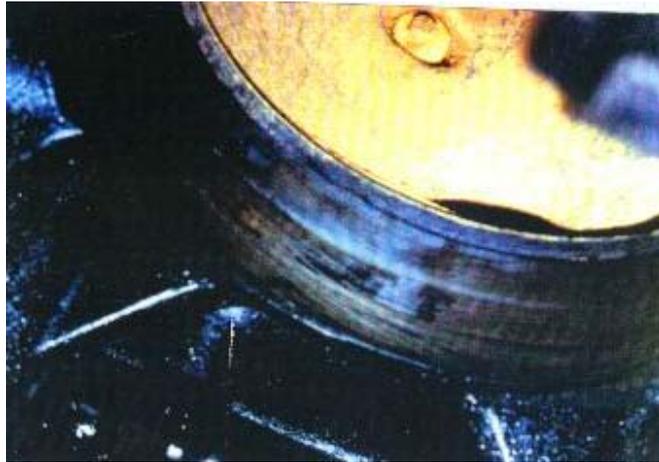
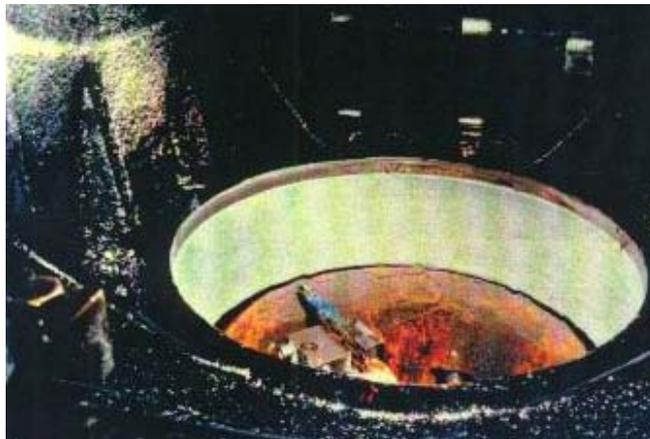
**REP-# 049**

Through leakages at the sealing surface of a cylinder liner's engine block cooling water flew out. The reconstruction work was affected with MM-metal SS-steel and Hardener yellow at eight cylinder block threads. After the application procedure the seats were machined to nominal diameter 308 mm. The main engine was an engine Daihatsu type 8 DSM 26, power 1252 kW, 720 U/min.

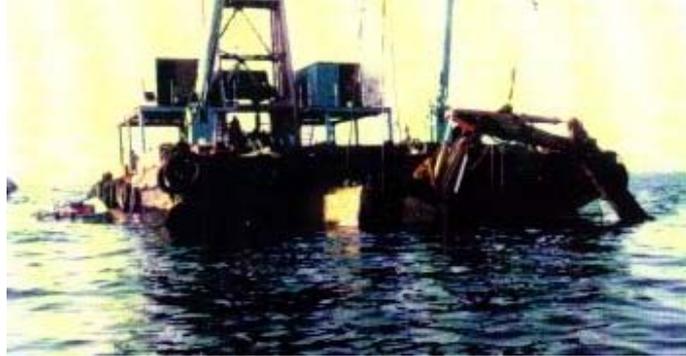
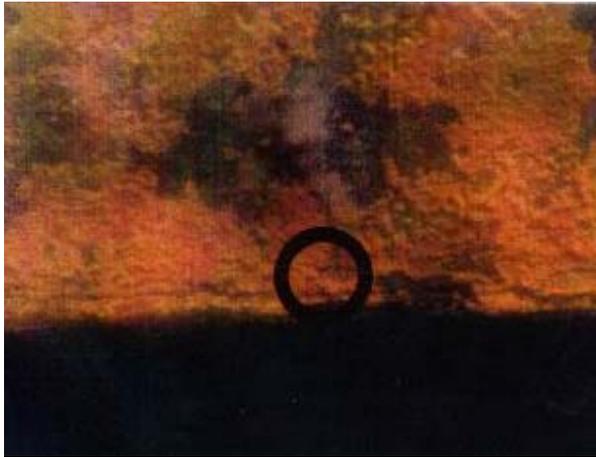
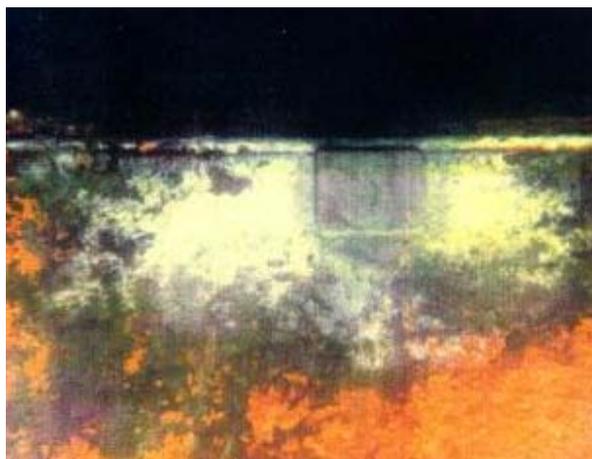
**REP-# 061**

A leakage at the stern of a barge was sealed under water using MM-metal UW with Hardener UW9. The repair was completed within 30 minutes time.

061	A leakage at the stern of a barge was sealed under water using MM-metal UW with Hardener UW9. The repair was completed within 30 minutes time.

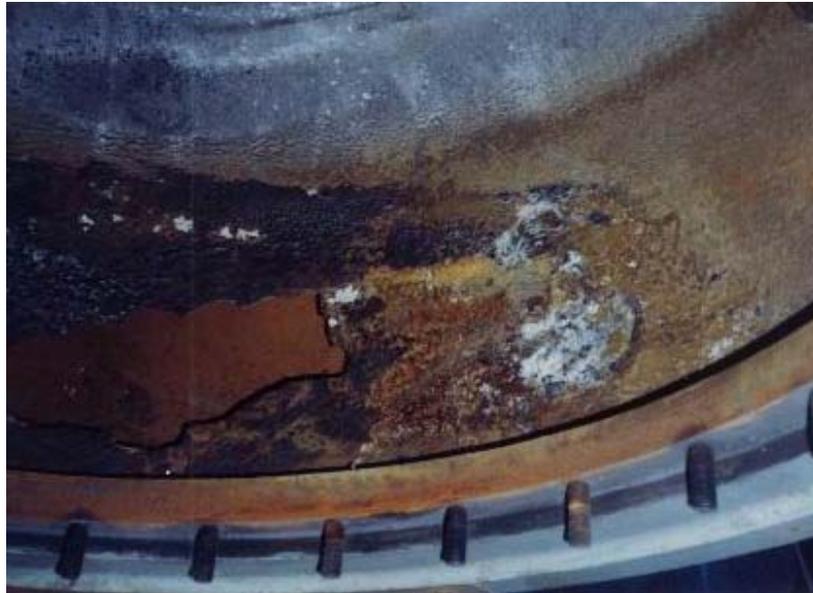
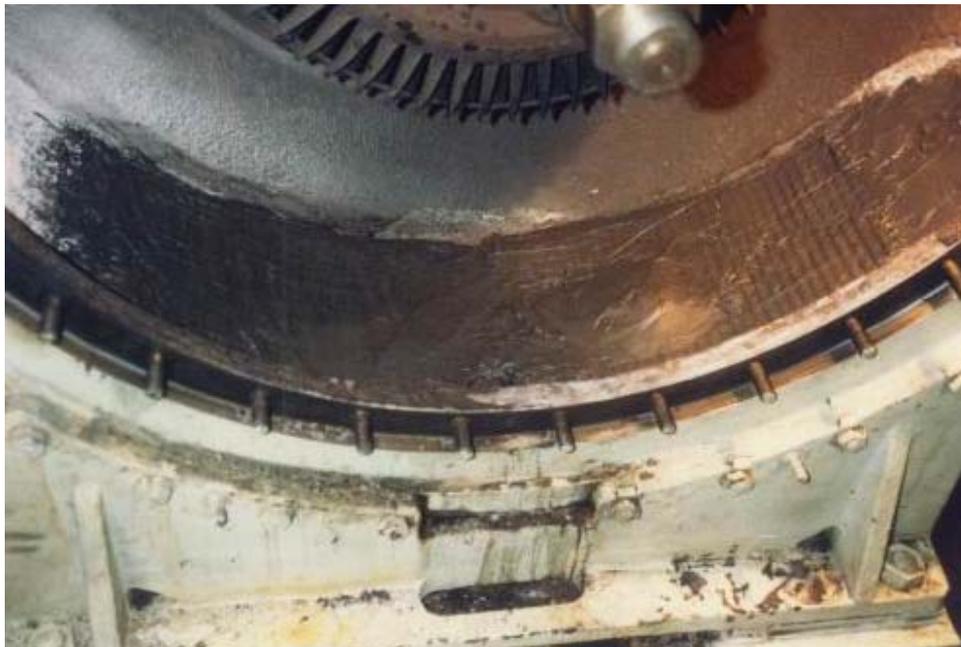
**REP-# 084**

Repair of a turbo charger on board of a ship: during a voyage problems occurred at a turbo charger. The turbine inlet casing was removed and after cleaning a wasted area of appr. 600 mm x 130 mm on the lower part of the casing was revealed. Due to the technical possibilities on board the repair was carried out with MM-metal SS-steelceramic and a steel plate as reinforcement. At an exhaust temperature of appr. 400 °C in this repair area today MultiMetall's VP 10-500 would have been the better choice.

- 075 Elimination of cavitation damages at a bronze propeller and a steel propeller with Ceramium and Hardener CE.
- 084 Repair of a turbo charger on board of a ship: during a voyage problems occurred at a turbo charger. The turbine inlet casing was removed and after cleaning a wasted area of appr. 600 mm x 130 mm on the lower part of the casing was revealed. Due to the technical possibilities on board the repair was carried out with MM-metal SS-steelceramic and a steel plate as reinforcement. At an exhaust temperature of appr. 400 °C in this repair area today MultiMetall's VP 10-500 would have been the better choice.

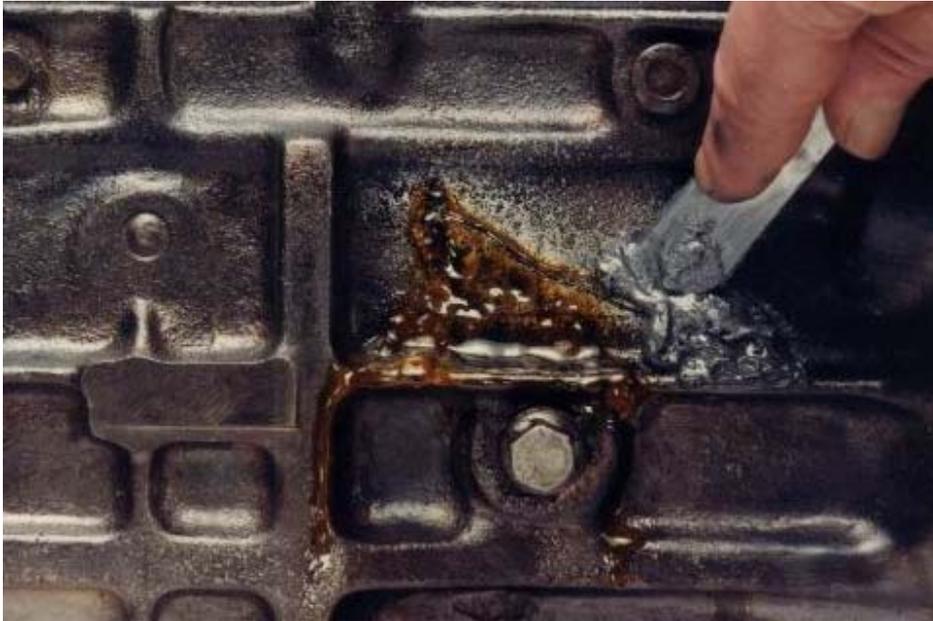
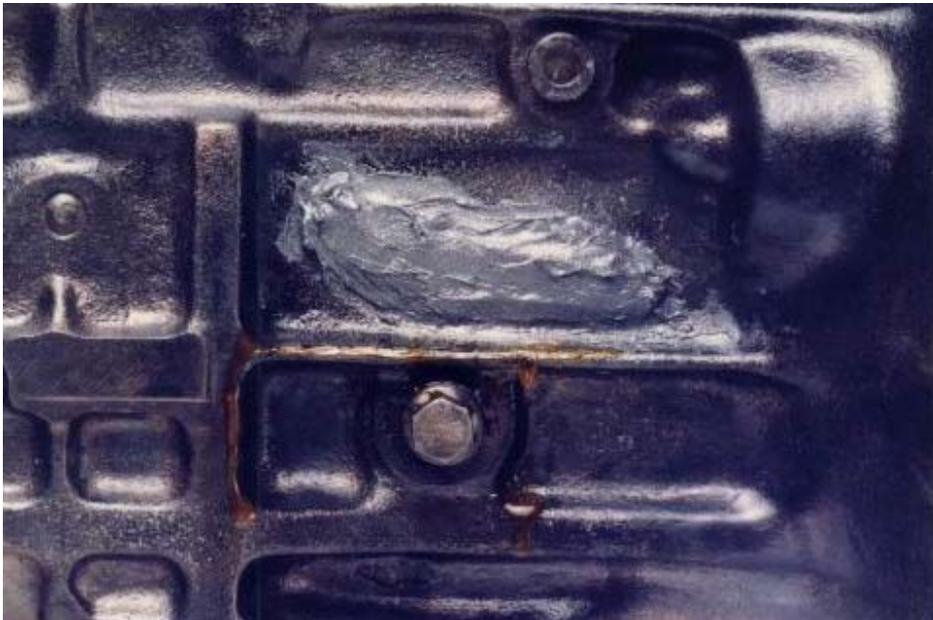
**REP-# 088**

A machine casing was repaired by using MM-metal oL-steelceramic and Hardener red and afterwards Hardener yellow. The application has been done using the direct-MM-bonding technology.

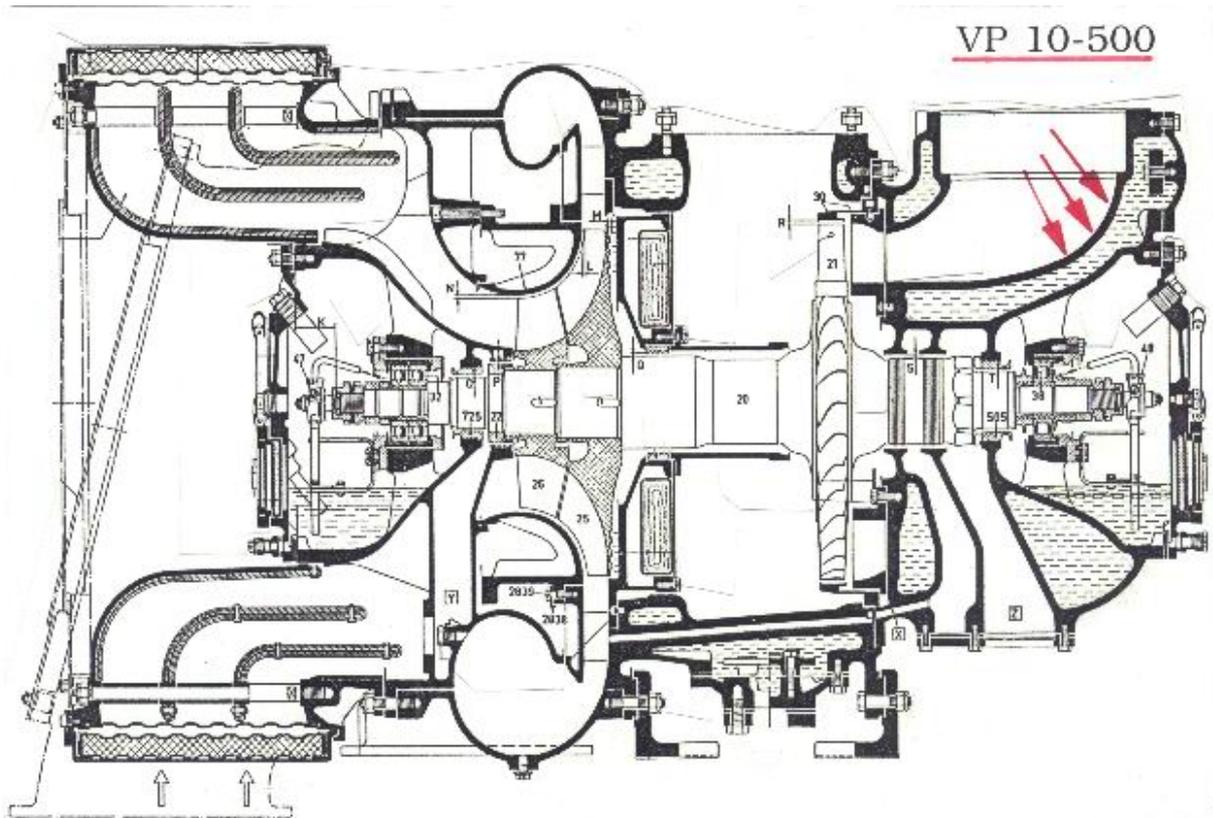
REP-# 102

Repair of a ship's turbocharger with VP 10-500. Scourings, cracks and apertures from the gas entrance to the cooling water side were repaired with VP 10-500. For the reinforcement two layers of MM-Fabric tape (glass fibre) were used.

- 100 Corrosion protective coating of ship hatches with VP 10-017.
- 102 Repair of a ship's turbocharger with VP 10-500. Scourings, cracks and apertures from the gas entrance to the cooling water side were repaired with VP 10-500. For the reinforcement two layers of MM-Fabric tape (glass fibre) were used.

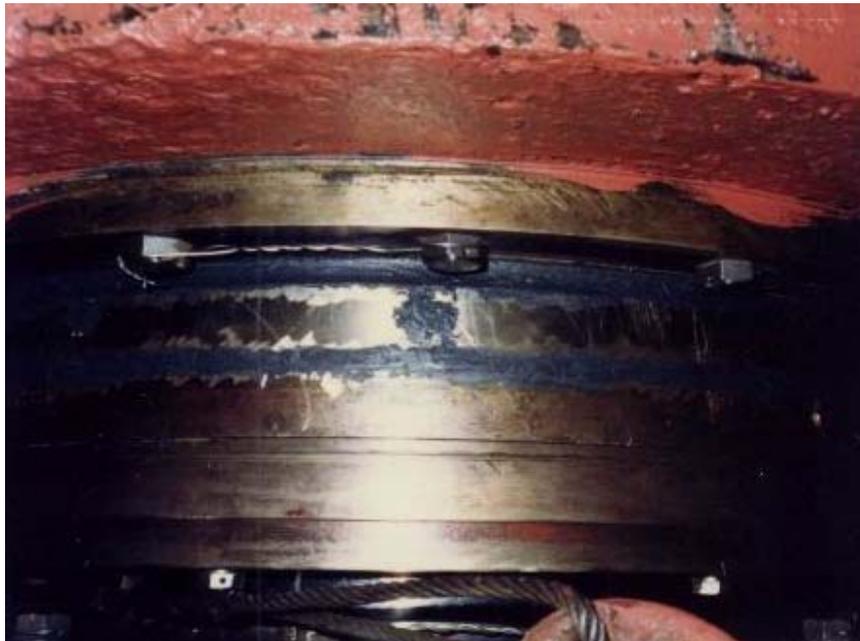
**REP-# 115**

Repair of a leaking simplex compact packing. The repair was difficult due to oil pouring out of the repair site. Therefore it was decided to use the direct-MM-bonding method by applying the PolymerMetall directly on the greasy surface. Here MM-metal oL-steelceramic with Hardener red was chosen.

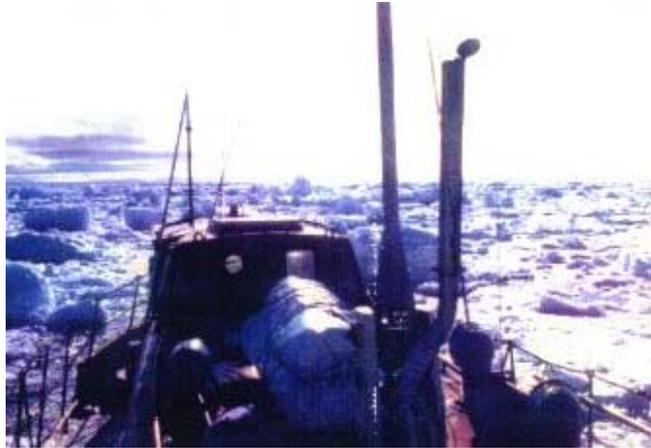
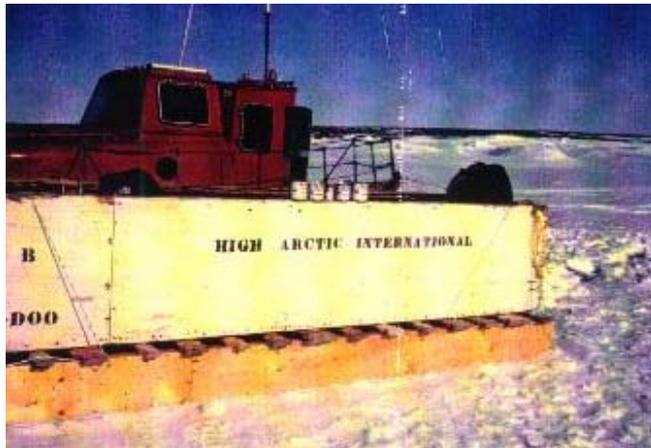
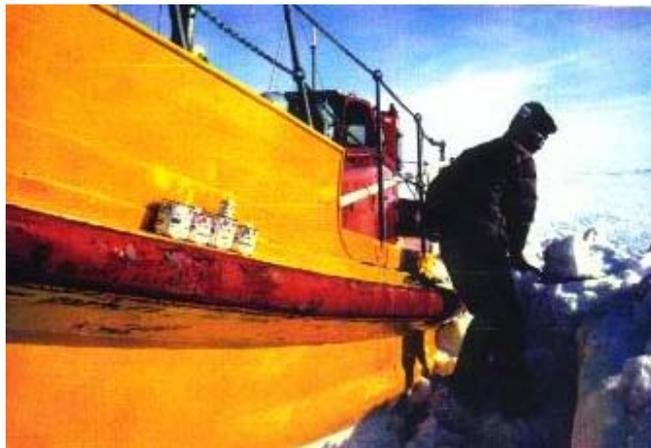
REP-# 123

Repairs with MM-metal UW and Hardener UW3 are possible under arctic conditions at temperatures even down to minus 20 °C.

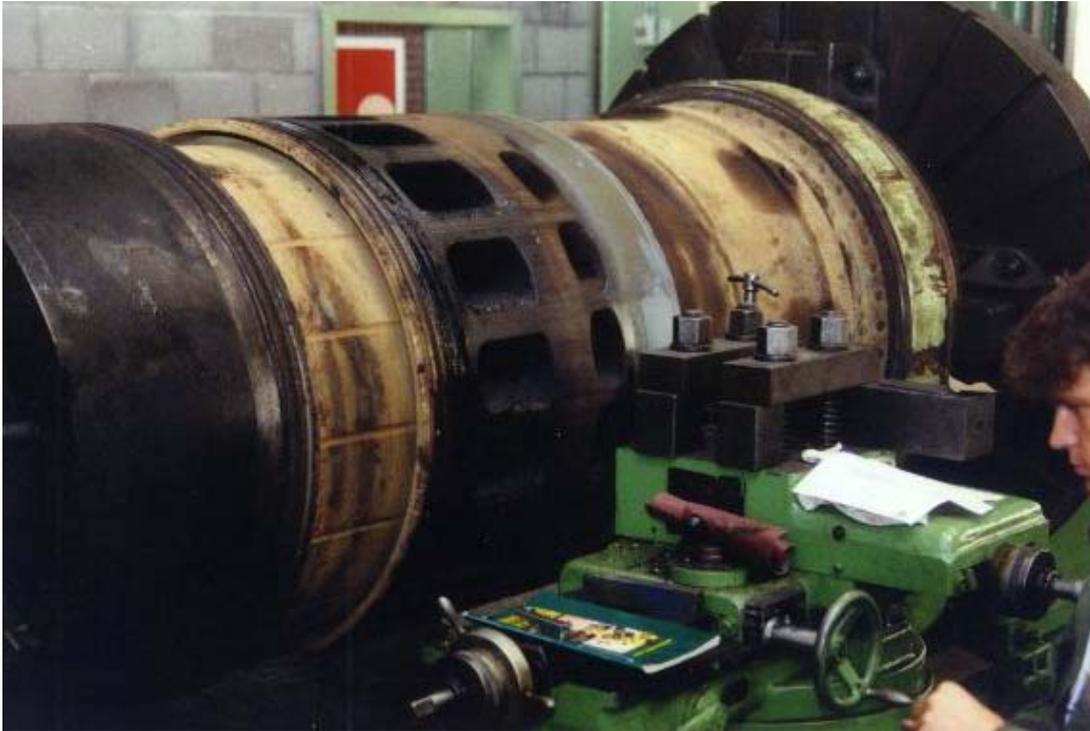
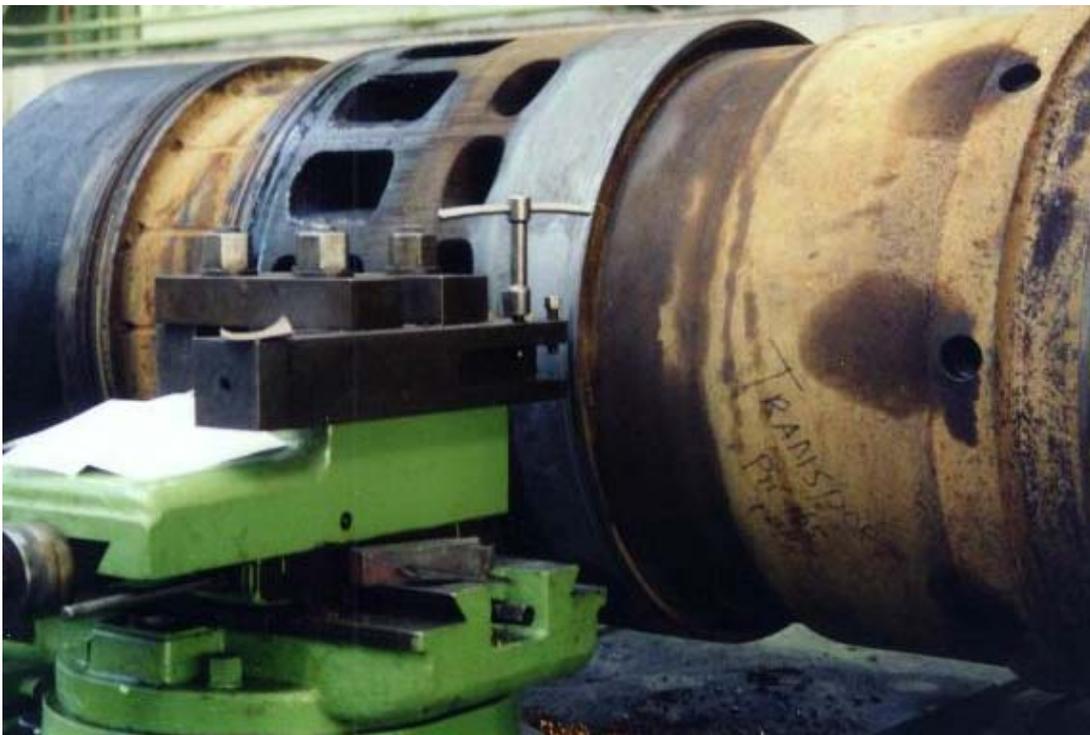
REP-# 125

Repair of two-stroke engine cylinder liners Sulzer RND 76N ship's diesel engine with MM-metal SS-steel and Hardener yellow. The outer diameter is 900 mm and the inner diameter is 760 mm.

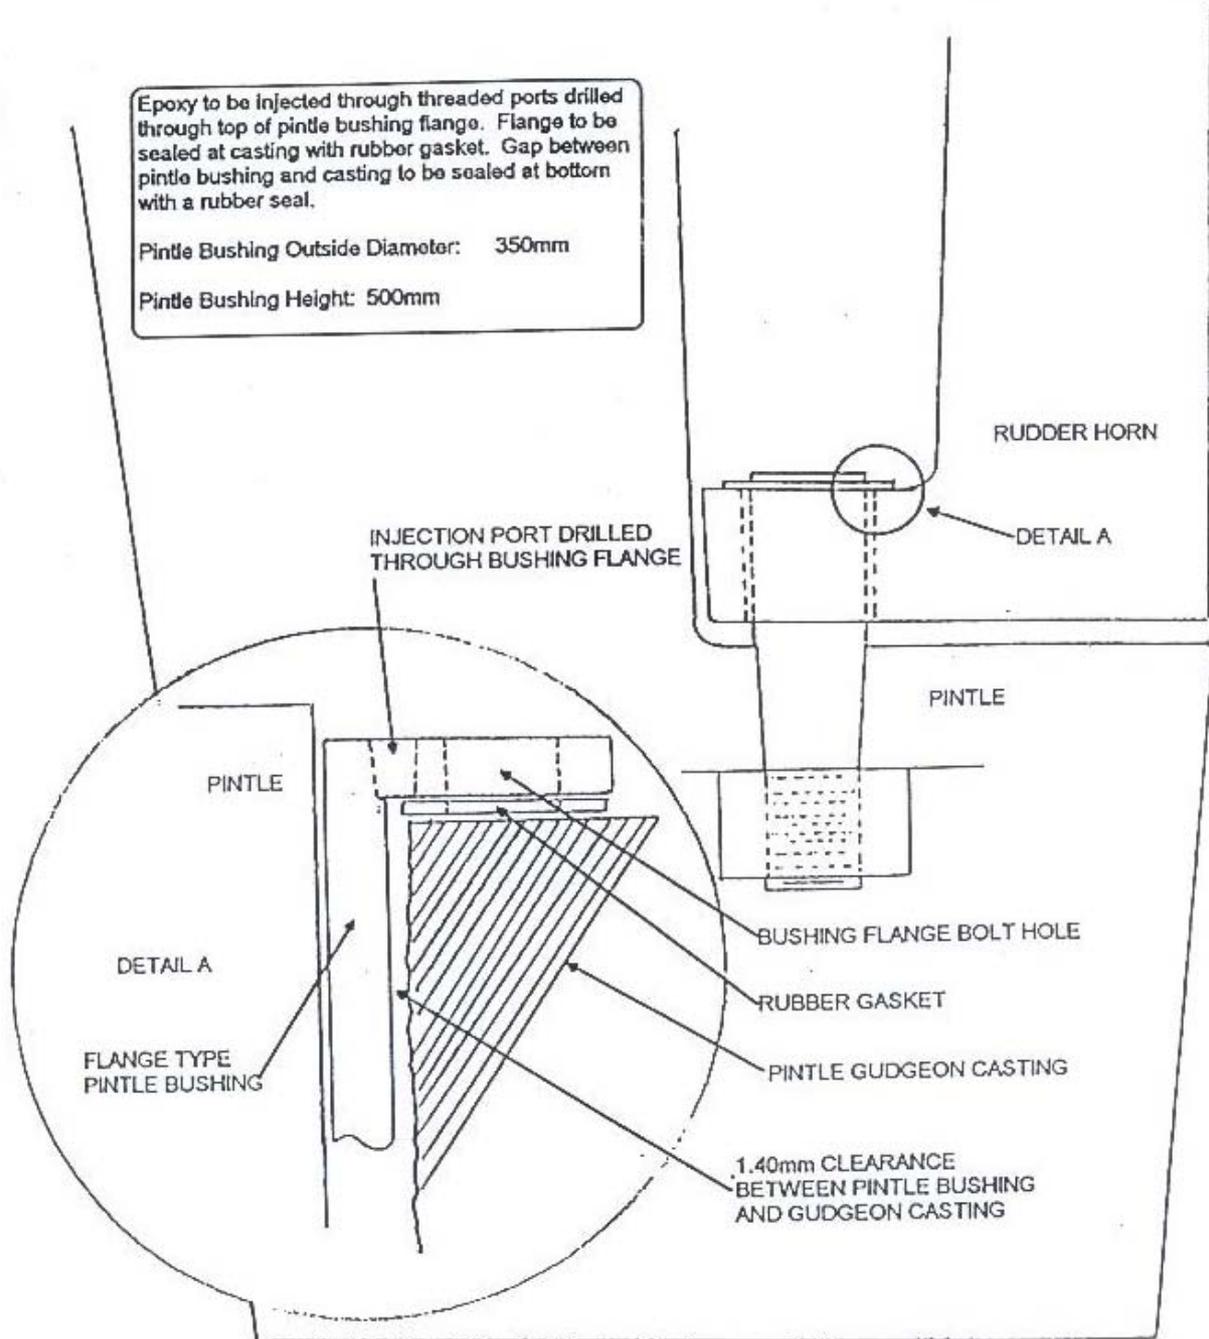
REP-# 133

The seat of a vessel's pintle bushing has been restored. At first under water the pintle bushing was fixed at a temperature of 2-3 °C. Then MM-metal UW with Hardener UW9 was injected through several threaded ports drilled into the bushing flange. Here an appr. 1,4 mm clearance between pintle bushing and gudgeon casting filled. The repair was carried out by a Canadian diving company. Because of the quick total curing time of the PolymerMetal in spite of the low temperature the vessel was ready for action again within short time.

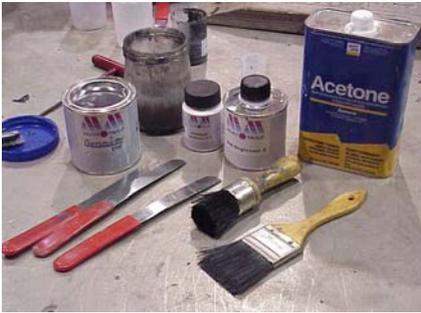
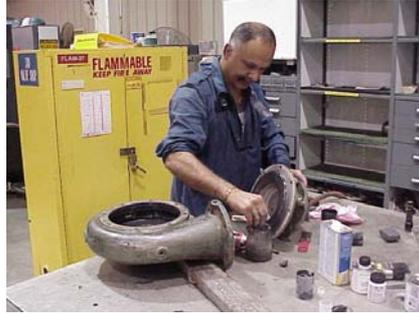
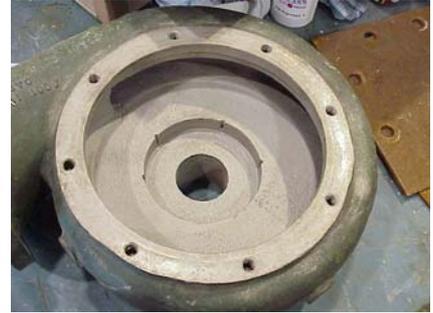
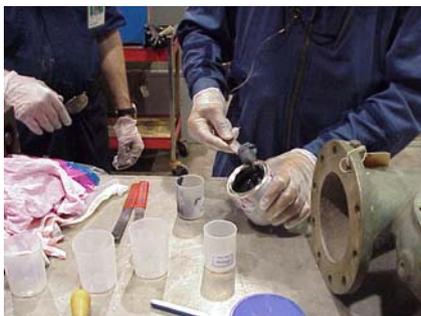
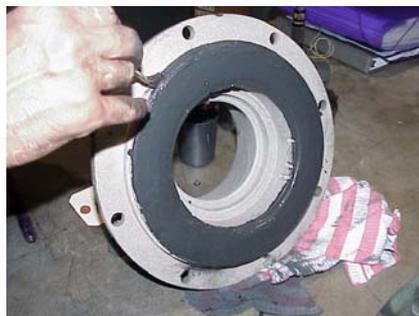
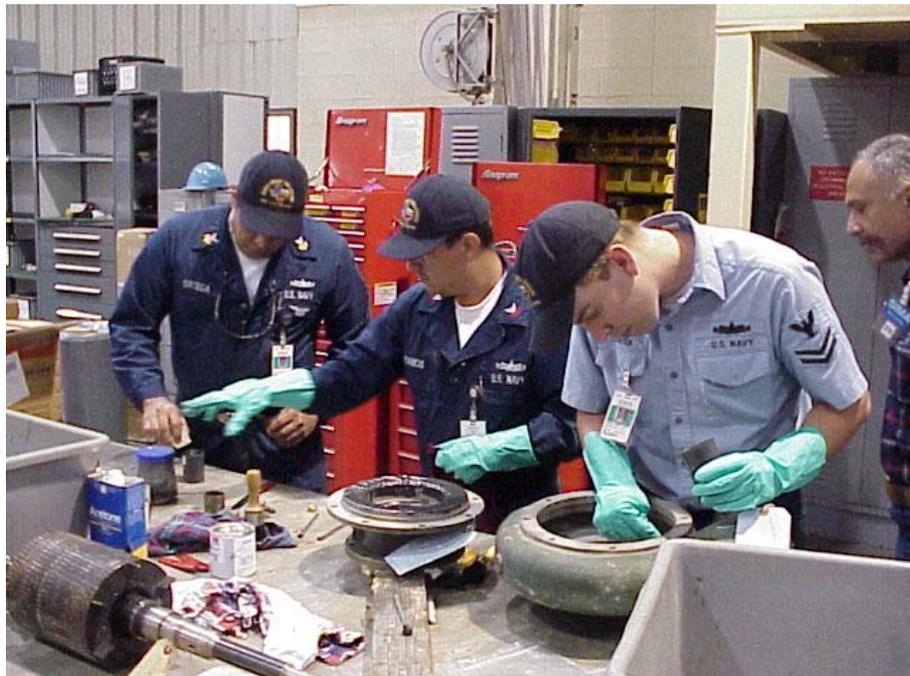
REP-# 136

A worn pump casing was coated with Ceramium liquid. Depending on the application consistency, Ceramium can be applied with a brush, a spatula or any other suitable tool or by pouring or injecting. Before coating, the surface must be roughened e.g. by sand blasting and then cleaned with MM-Degreaser Z or Acetone.
